CHAMP HOME INSPECTIONS

HOME INSPECTION REPORT

123 Main Street
Anytown, GA 30000

Date of Inspection: 1/1/00

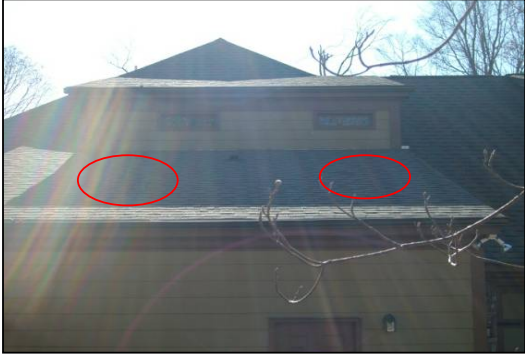
Location	Description	
<p>XVIII. Pictures #1 - #2</p> <div data-bbox="130 386 375 487" style="border: 1px solid black; padding: 5px; margin-top: 10px;"> <p>Loose shingles noted above garage</p> </div>

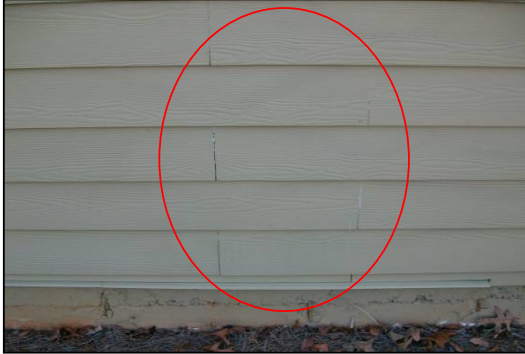
<div data-bbox="1707 386 1950 487" style="border: 1px solid black; padding: 5px; margin-top: 10px;"> <p>Unsealed siding joints</p> </div>
<p>#3 - #4</p> <div data-bbox="130 768 375 868" style="border: 1px solid black; padding: 5px; margin-top: 10px;"> <p>Unsealed and loose faucet handle</p> </div>

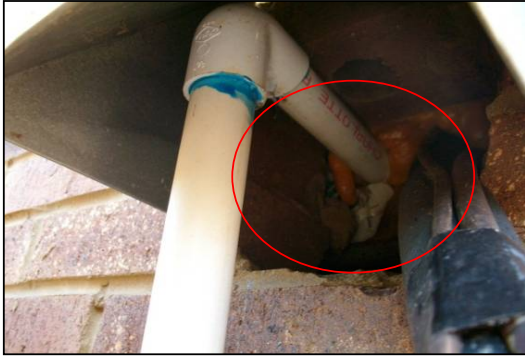
<div data-bbox="1707 768 1950 868" style="border: 1px solid black; padding: 5px; margin-top: 10px;"> <p>Unsealed brick around ac line</p> </div>
<p>#5 - #6</p> <div data-bbox="130 1146 375 1247" style="border: 1px solid black; padding: 5px; margin-top: 10px;"> <p>Window lock missing in two car garage</p> </div>

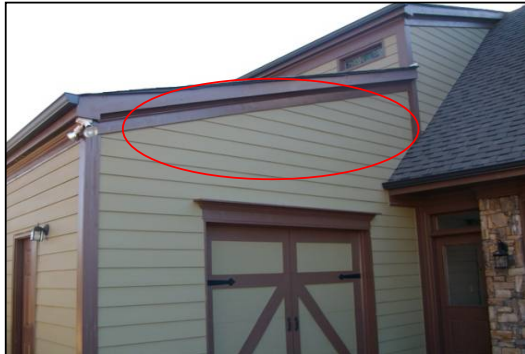
<div data-bbox="1707 1146 1950 1247" style="border: 1px solid black; padding: 5px; margin-top: 10px;"> <p>No attic access above one car garage</p> </div>

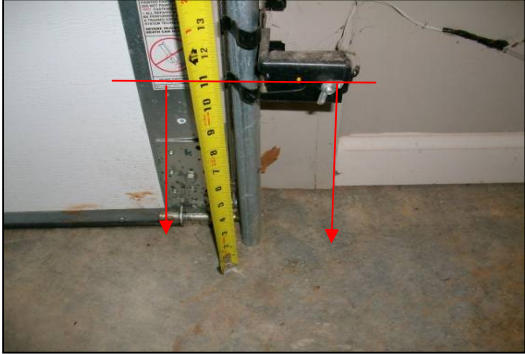
Location	Description	
<p>XVIII. Pictures #7 - #8</p> <div data-bbox="128 399 373 500" style="border: 1px solid black; padding: 5px; margin-top: 10px;"> <p>Garage door sensors too high</p> </div>

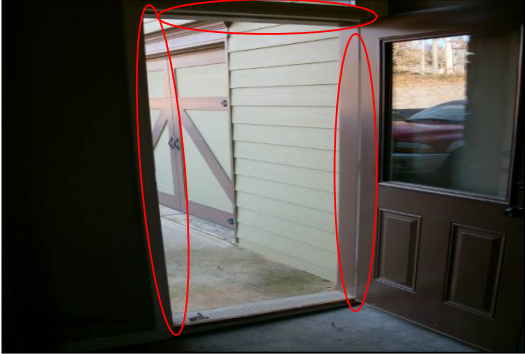
<div data-bbox="1713 399 1957 500" style="border: 1px solid black; padding: 5px; margin-top: 10px;"> <p>No weather stripping on exterior garage entry door</p> </div>
<p>#9 - #10</p> <div data-bbox="128 743 373 883" style="border: 1px solid black; padding: 5px; margin-top: 10px;"> <p>Torn weather stripping on bottom of interior garage entry door</p> </div>

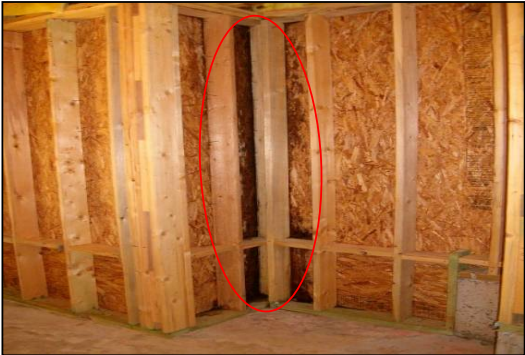
V. Foundation	<p>Water intrusion and rot were noted on the wall below the right fireplace. Repair. (See picture #10)</p> <p>Evidence of wood destroying organisms were noted between the concrete floor and right foundation wall. Recommend further evaluation and treatment from a licensed pest control company. (See picture #11)</p> <p>Two unsecured foundation anchor straps were noted next to the front foundation wall. Resecure. (See picture #12)</p> <p>No caps were noted on the sump pump area. Recommend installation. (See picture #13)</p> <p>Vertical cracks were noted on the left foundation wall. Monitor for further cracking and seal as needed.</p>

<div data-bbox="1713 773 1957 873" style="border: 1px solid black; padding: 5px; margin-top: 10px;"> <p>Water intrusion and rot on right wall in the basement</p> </div>
<p>#11 - #12</p> <div data-bbox="128 1154 373 1255" style="border: 1px solid black; padding: 5px; margin-top: 10px;"> <p>Active wood destroying organism tunnels in basement</p> </div>

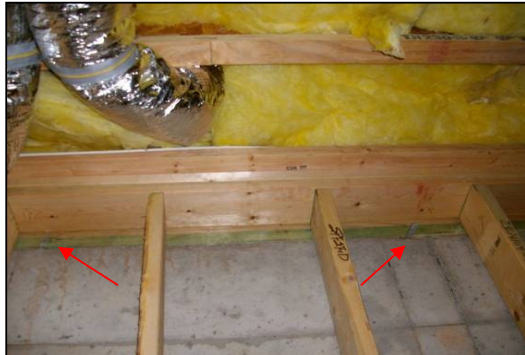
<div data-bbox="1713 1146 1957 1247" style="border: 1px solid black; padding: 5px; margin-top: 10px;"> <p>Unsecured foundation anchor straps in basement</p> </div>

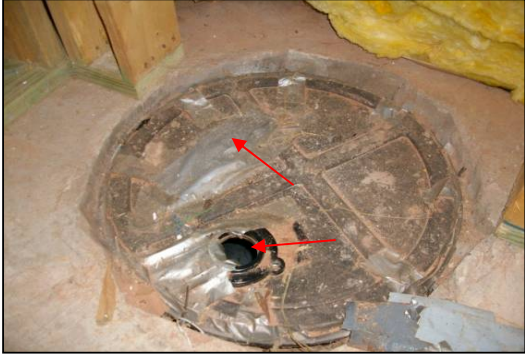
Location	Description	
<p>XVIII. Pictures #13 - #14</p> <div data-bbox="134 404 380 505" style="border: 1px solid black; padding: 5px; margin-top: 10px;"> <p>No caps on sump pump top</p> </div>

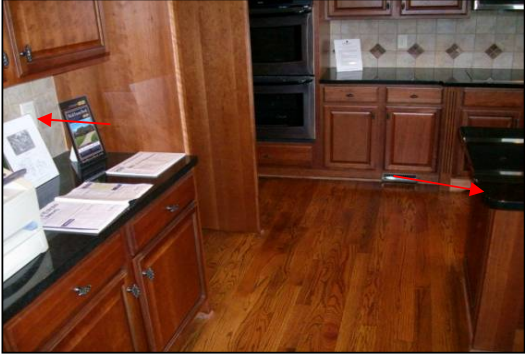
Location	Description
VI. Kitchen	<p>The island outlet and one outlet next to the refrigerator tested as open neutral. Recommend further evaluation and repairs from a licensed electrician. (See picture #14 for location of outlets)</p> <p>The dishwasher was not secured to the cabinets. Repair. (See picture #15)</p> <p>The dishwasher was not tested, due to the drain line was disconnected below the sink. Repair. (See picture #16)</p> <p>The garbage disposal did not operate when tested. Repair.</p> <p>No water hammer arrestor was noted on the refrigerator water line connection. Recommend installation when a quick closing valve is used. Reference: 2006 IRC P2903.5 (See picture #17 for current installation & picture #18 for recommended installation method)</p>
VII. General Interior	<p>One loose spindle was noted on the handrail in the second floor hallway. Resecure. (See picture #19)</p>
IX. Laundry Facilities	<p>No water hammer arrestor was noted on the washing machine connections. Recommend installation when a quick closing valve is used. Reference: 2006 IRC P2903.5 (See picture #20 for current installation & picture #21 for recommended installation method)</p>

<div data-bbox="1713 404 1959 505" style="border: 1px solid black; padding: 5px; margin-top: 10px;"> <p>Location of two outlets that tested as open neutral</p> </div>
<p>#15 - #16</p> <div data-bbox="134 781 380 883" style="border: 1px solid black; padding: 5px; margin-top: 10px;"> <p>Dishwasher not secured to countertop</p> </div>

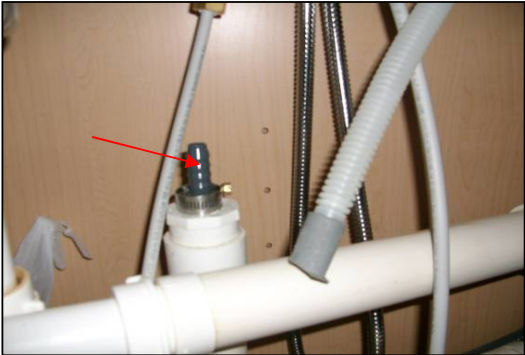
<div data-bbox="1713 781 1959 883" style="border: 1px solid black; padding: 5px; margin-top: 10px;"> <p>Dishwasher drain line disconnected</p> </div>
<p>#17 - #18</p> <div data-bbox="134 1149 380 1252" style="border: 1px solid black; padding: 5px; margin-top: 10px;"> <p>No water hammer arrestor on refrigerator line</p> </div>

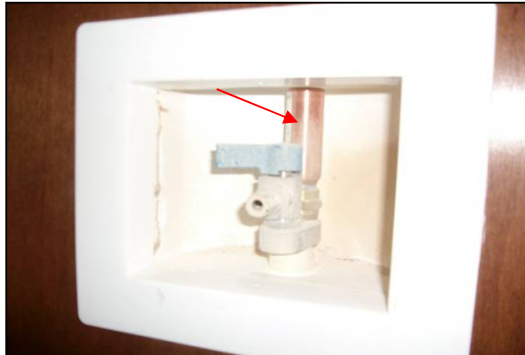
<div data-bbox="1713 1138 1959 1252" style="border: 1px solid black; padding: 5px; margin-top: 10px;"> <p>Recommended installation method of water hammer arrestor</p> </div>
