CHAMP HOME INSPECTIONS

HOME INSPECTION REPORT

123 Main Street
Anytown, GA 30000

Date of Inspection: 1/1/00

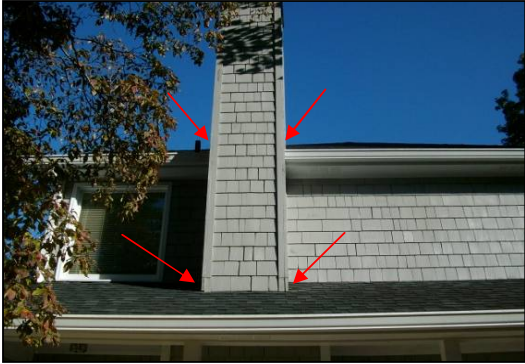
Location	Description	
<p>XVIII. Pictures #1 - #2</p> <p>No kickout flashing noted on sides of chimney</p>

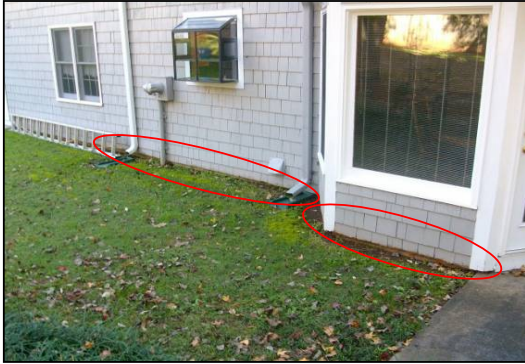
<p>Rotted siding and trim</p>
<p>#3 - #4</p> <p>Rotted trim</p>

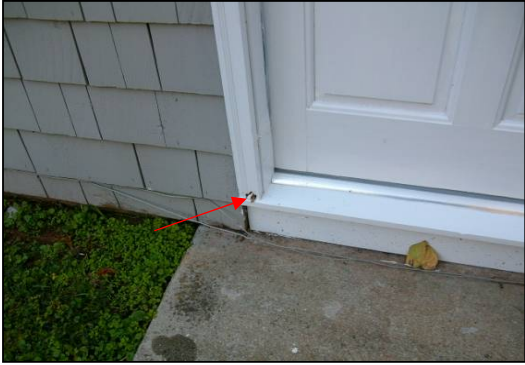
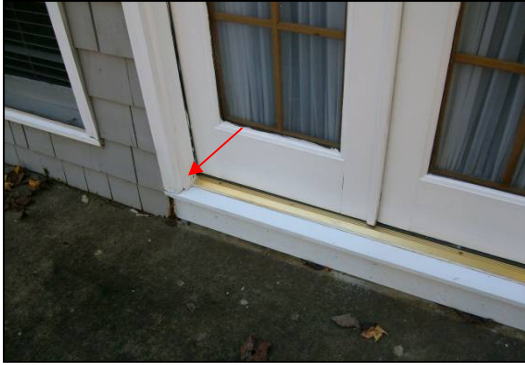
<p>Rotted trim and wood destroying organisms</p>
<p>#5 - #6</p> <p>Rotted trim</p>

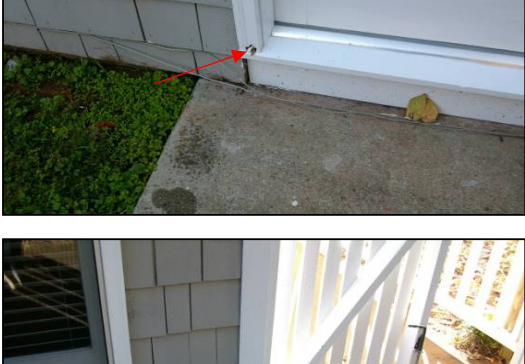
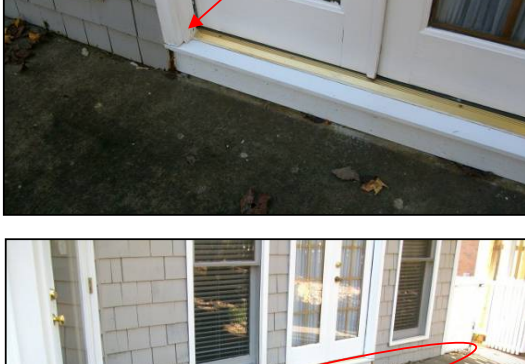
<p>Rotted siding and trim</p>

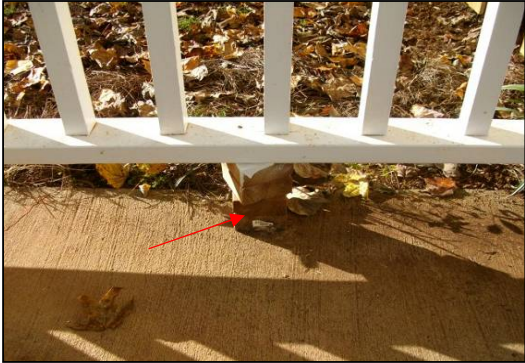
Location	Description	
<p>XVIII. Pictures #7 - #8</p> <div data-bbox="149 386 365 500" style="border: 1px solid red; padding: 5px; margin-top: 20px;"> Non-painted trim below front railings </div>	<div style="display: flex; justify-content: space-around;"> <div data-bbox="520 269 1041 630">

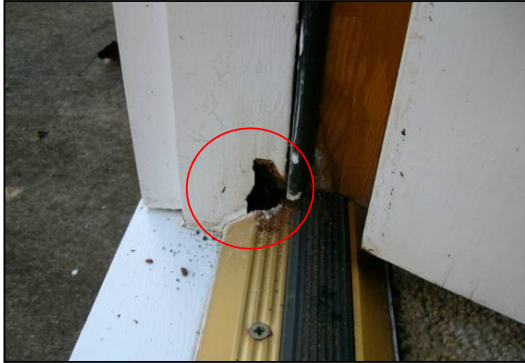
</div> </div> <div data-bbox="1724 386 1940 500" style="border: 1px solid red; padding: 5px; margin-top: 20px;"> Evidence of wood destroying organisms </div>	
<p>#9 - #10</p> <div data-bbox="142 789 359 902" style="border: 1px solid red; padding: 5px; margin-top: 20px;"> Garage door sensors too high </div>	<div style="display: flex; justify-content: space-around;"> <div data-bbox="520 652 1041 1013">

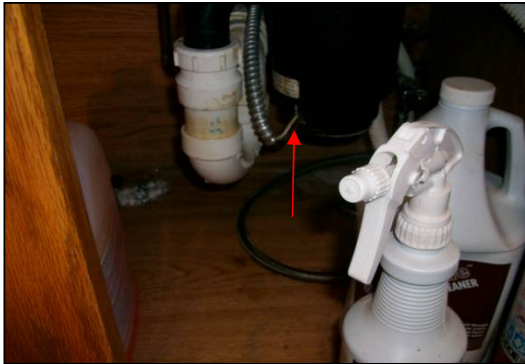
</div> </div> <div data-bbox="1724 781 1940 894" style="border: 1px solid red; padding: 5px; margin-top: 20px;"> Loose conduit and drain leaking </div>

IV. Garage/Carport	17. The left garage door safety sensors were installed 9" above the ground. Recommend installing sensors between 4" - 6" above the ground. (See picture #9)
VI. Kitchen	<p>18. The countertop outlets in the kitchen were not gfci rated outlets. Recommend replacing with gfci rated outlets for added safety.</p> <p>19. Water was noted dripping below the right side of the sink when tested. Repair.</p> <p>20. The conduit was loose for the garbage disposal wires. Resecure. (See picture #10)</p>

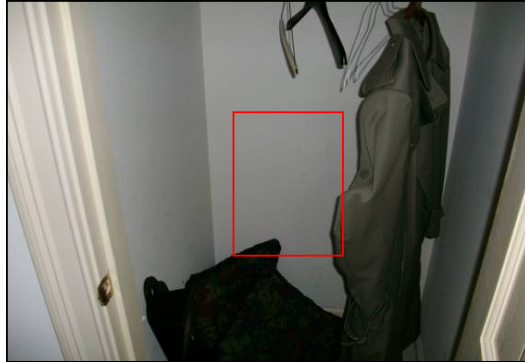
<p>#11 - #12</p> <div data-bbox="149 1170 365 1284" style="border: 1px solid red; padding: 5px; margin-top: 20px;"> No access to space under front stairs </div>	<div style="display: flex; justify-content: space-around;"> <div data-bbox="520 1036 1041 1396">

Location	Description
VII. General Interior	<p>21. No access was noted under the front stairs. Recommend installing an access panel to this space in the first floor hall closet. (See picture #11)</p> <p>22. Several windows would not open throughout the house and are probably painted shut. Ensure all windows open and close properly.</p> <p>23. The chimney flue was dirty. Recommend cleaning from a licensed chimney sweep.</p> <p>24. Recommend sealing around the fireplace gas line at the point of entry into the fireplace. (See picture #12)</p> <p>25. Water spots were noted on the family room ceiling above the fireplace. Monitor for leaks.</p> <p>26. The handrails were loose on the front stairs. Resecure.</p>
VIII. Electrical	<p>27. Two double tapped breakers were noted in the panel box. Repair. (See picture #13)</p> <p>28. The breakers were not marked in the panel cover. Repair.</p> <p>29. Arc and burn marks were noted on the wire for the bottom left breaker. Recommend further evaluation from a licensed electrician. (See picture #13)</p> <p>30. One 20 amp breaker in the panel next to the ac units was overfused for the maximum breaker rating labeled on the rear ac unit. Repair.</p> <p>31. No bonding wire was noted on the main water line or water lines above the water heater. Recommend installation.</p>

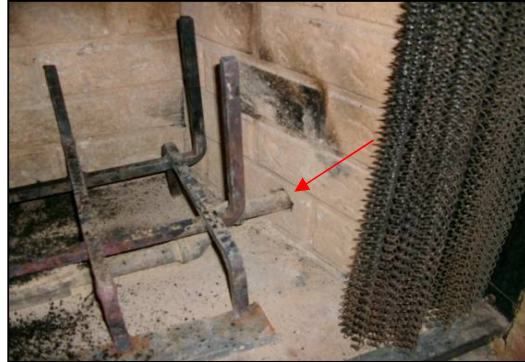
</div> </div> <div data-bbox="1724 1146 1940 1260" style="border: 1px solid red; padding: 5px; margin-top: 20px;"> Gas line not sealed on fireplace </div>

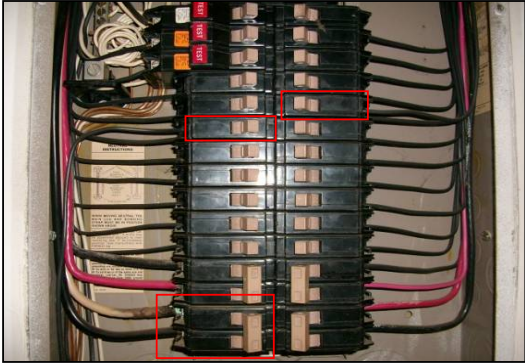
Location	Description	
<p>XVIII. Pictures #13 - #14</p> <div data-bbox="142 375 363 492" style="border: 1px solid red; padding: 5px; margin-top: 10px;"> <p>Two double tapped breakers and one melted wire</p> </div>

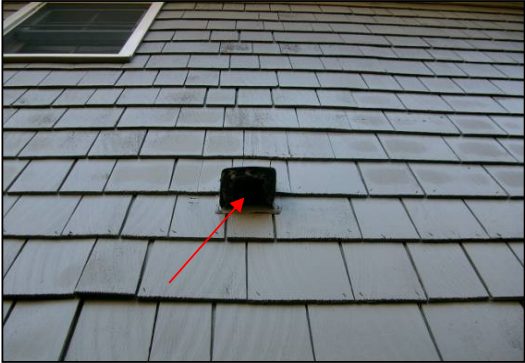
<div data-bbox="1728 402 1948 513" style="border: 1px solid red; padding: 5px; margin-top: 10px;"> <p>Dryer vent broken on rear side of house</p> </div>
<p>#15 - #16</p> <div data-bbox="142 805 363 915" style="border: 1px solid red; padding: 5px; margin-top: 10px;"> <p>Exposed pipe on rear side of house</p> </div>

IX. Laundry Facilities	<p>32. Water spots were noted on the wall next to the sink. Monitor for leaks.</p> <p>33. The laundry room door would not close properly when tested. Readjust the door hardware.</p> <p>34. The right wall outlet was not a gfci rated outlet. Recommend replacing with gfci rated outlet, due to within 6' of the sink.</p> <p>35. The dryer vent was broken on the rear side of the house. Repair. (See picture #14)</p>

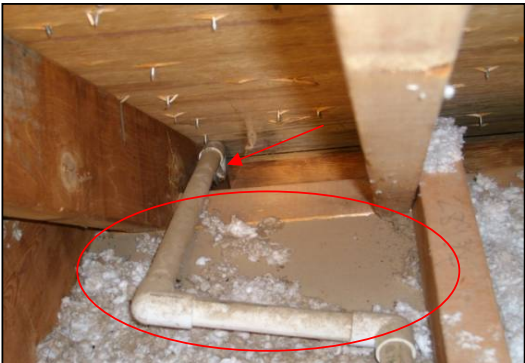
<div data-bbox="1728 781 1948 891" style="border: 1px solid red; padding: 5px; margin-top: 10px;"> <p>Overflow pipe stops in attic and low insulation</p> </div>
<p>#17 - #18</p> <div data-bbox="142 1174 363 1284" style="border: 1px solid red; padding: 5px; margin-top: 10px;"> <p>Overflow pipe stops in soffit and bath vented to attic</p> </div>

Both furnace overflow pan drain pipes terminate into the soffits and the right pipe also goes upward over a ceiling joist. Recommend terminating pipes to the exterior of the house.

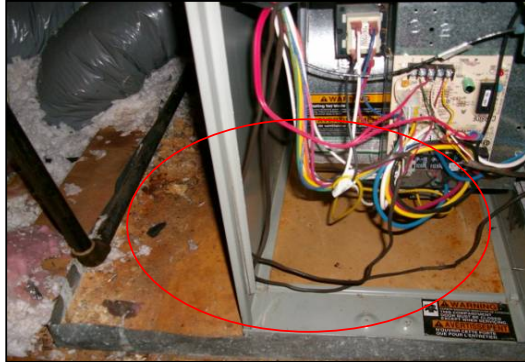
<div data-bbox="1728 1174 1948 1284" style="border: 1px solid red; padding: 5px; margin-top: 10px;"> <p>Rust noted in overflow pan</p> </div>

Rust was noted in the overflow pan below the left furnace. Monitor working conditions and recommend replacing pan.

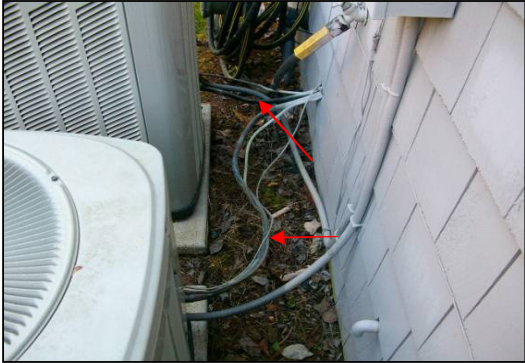
Location	Description	
<p>XVIII. Pictures #19 - #20</p> <p>No insulation on ac lines</p>

No insulation was noted on the ac lines next to the ac units and torn insulation was noted on the ac line in the attic. Repair.

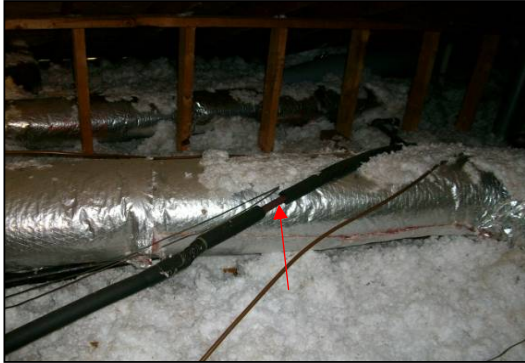
<p>Torn insulation on ac line in attic</p>
<p>#21 - #22</p> <p>Erosion under ac unit</p>

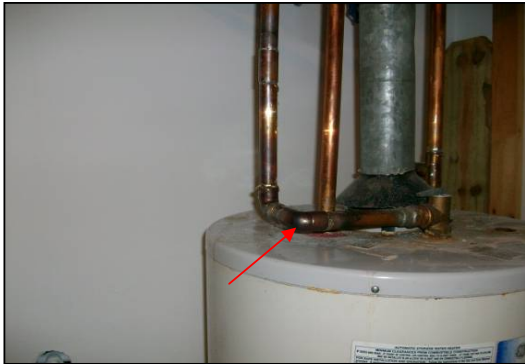
<p>No drain on tpr valve pipe</p>
<p>#23 - #24</p> <p>Open cavity space and insulation touching pipe</p>

The water heater tpr valve pipe flowed upward from the water heater. Recommend installing a drain at the lowest point of this pipe to prevent any water from collecting at the bottom of the pipe and obstructing the valve.

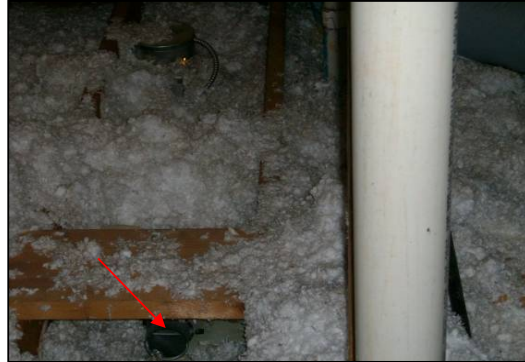
<p>Bathroom fan vented into attic</p>

The bathroom fans were vented into the attic. Recommend venting to the exterior.
Low levels of insulation were noted along the rear side of the attic near the soffits. Recommend re-distributing insulation evenly.

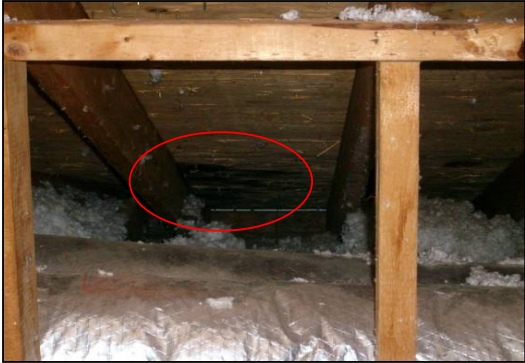
Location	Description	
<p>XVIII. Pictures #25 - #26</p> <p>Water spots in attic</p>

Water spots were noted on the rear attic sheathing above the guest bedrooms. Monitor for leaks.
One loose set of wires was noted on the rear side of the roof. Recommend installing a junction box.

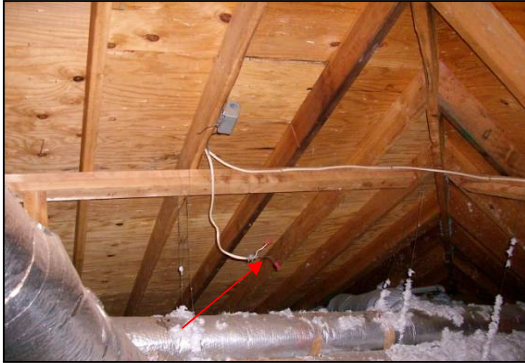
<p>Loose wires in attic</p>
<p>#27 - #28</p> <p>No handrail on attic stairs</p>

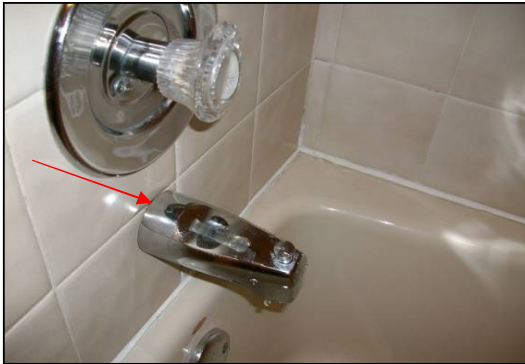
<p>Faucet not sealed in tub</p>
<p>#29 - #30</p> <p>Rusted tank bolts and evidence of leaks</p>

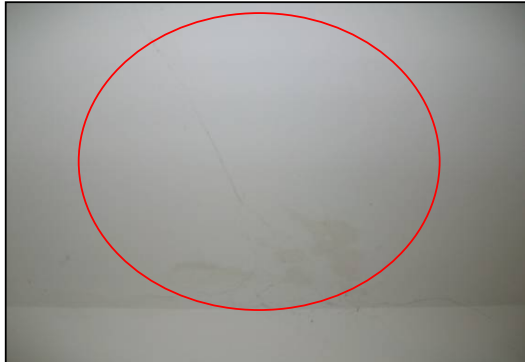
<p>Water spots in closet ceiling</p>
