# CHAMP HOME INSPECTIONS

## HOME INSPECTION REPORT

123 Any Street  
Any Town, GA 30000

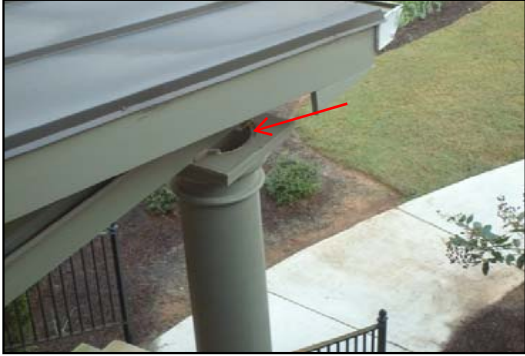
Location	Description	
<p>XVIII. Pictures #7 - #8</p> <div data-bbox="134 391 380 488" style="border: 1px solid black; padding: 5px; margin-top: 20px;"> <p>Open gaps on top of columns</p> </div>

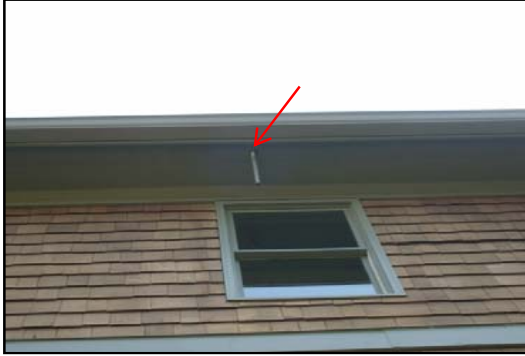
<div data-bbox="1709 391 1955 488" style="border: 1px solid black; padding: 5px; margin-top: 20px;"> <p>Pipe not sealed</p> </div>
<p>#9 - #10</p> <div data-bbox="134 773 380 870" style="border: 1px solid black; padding: 5px; margin-top: 20px;"> <p>Pipes and panel boxes not sealed</p> </div>

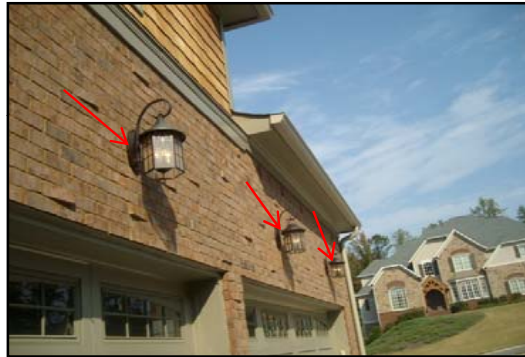
<div data-bbox="1709 773 1955 870" style="border: 1px solid black; padding: 5px; margin-top: 20px;"> <p>Lights not sealed</p> </div>
<p>#11 - #12</p> <div data-bbox="134 1146 380 1243" style="border: 1px solid black; padding: 5px; margin-top: 20px;"> <p>Gas line not sealed</p> </div>

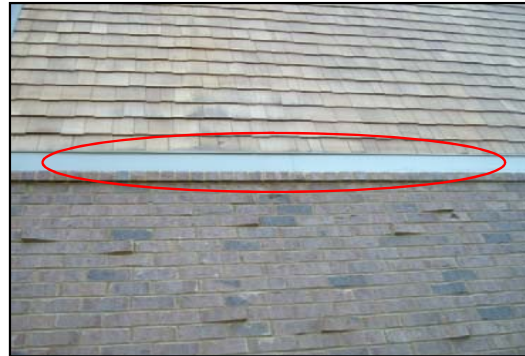
<div data-bbox="1709 1146 1955 1243" style="border: 1px solid black; padding: 5px; margin-top: 20px;"> <p>Trim not sealed</p> </div>

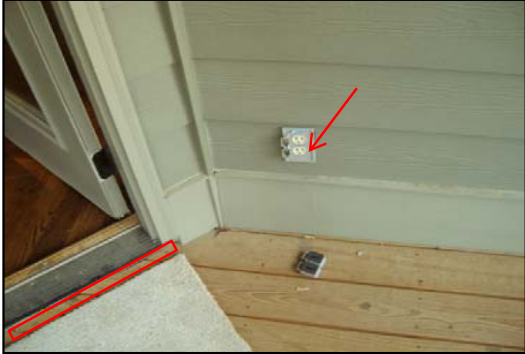
Location	Description	
<p><b>XVIII. Pictures</b> #13 - #14</p> <div data-bbox="132 365 378 503" style="border: 1px solid black; padding: 5px; margin-top: 10px;"> <p>Outlet cover broken and threshold support missing</p> </div>

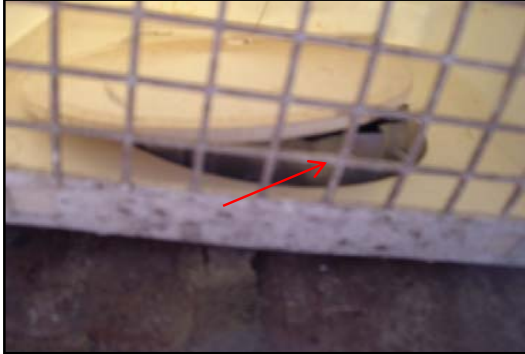
<div data-bbox="1707 391 1953 492" style="border: 1px solid black; padding: 5px; margin-top: 10px;"> <p>Vent stuck open</p> </div>
<p>#15 - #16</p> <div data-bbox="132 771 378 872" style="border: 1px solid black; padding: 5px; margin-top: 10px;"> <p>Rotted trim</p> </div>

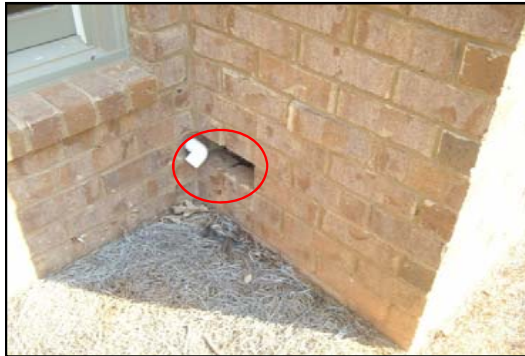
<div data-bbox="1707 771 1953 872" style="border: 1px solid black; padding: 5px; margin-top: 10px;"> <p>Missing brick</p> </div>
<p>#17 - #18</p> <div data-bbox="132 1149 378 1250" style="border: 1px solid black; padding: 5px; margin-top: 10px;"> <p>Missing shake</p> </div>

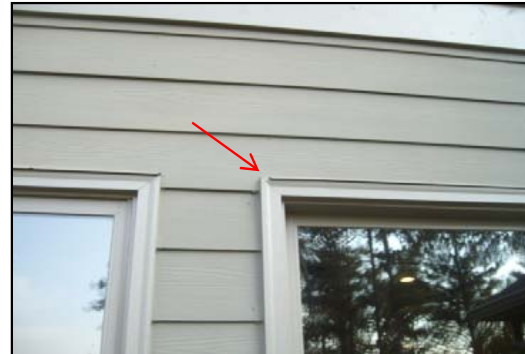
<div data-bbox="1707 1149 1953 1250" style="border: 1px solid black; padding: 5px; margin-top: 10px;"> <p>Head flashing too short</p> </div>

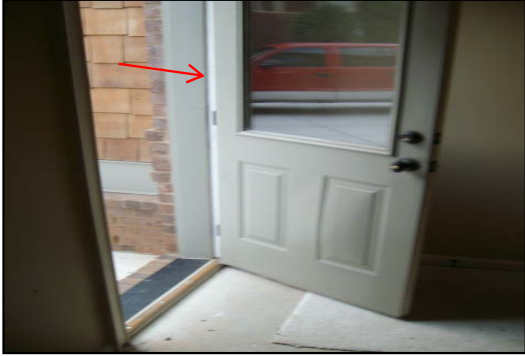
Location	Description	
<p>XVIII. Pictures #19 - #20</p> <div data-bbox="134 391 380 488" style="border: 1px solid black; padding: 5px; margin-top: 20px;"> <p>Missing weather stripping</p> </div>

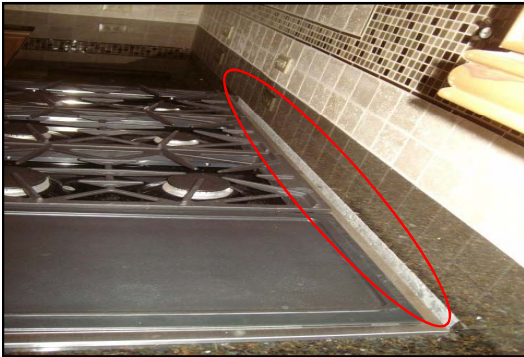
<div data-bbox="1709 773 1955 870" style="border: 1px solid black; padding: 5px; margin-top: 20px;"> <p>Large gap on counter top</p> </div>
<p>#23 - #24</p> <div data-bbox="134 1146 380 1243" style="border: 1px solid black; padding: 5px; margin-top: 20px;"> <p>Unable to determine use for switch</p> </div>

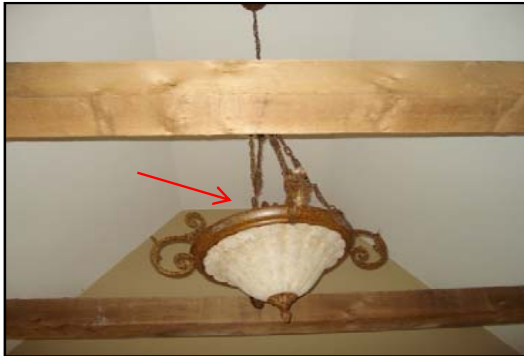
<div data-bbox="1709 1146 1955 1243" style="border: 1px solid black; padding: 5px; margin-top: 20px;"> <p>Broken light chain</p> </div>

<b>VII. General Interior</b>	<p><b><u>Den</u></b></p> <p>One chain was broken on the ceiling light. Repair. (See picture #24)</p> <p>The top sash was broken on the rear left window. Recommend replacing. (See picture #25)</p> <p><b><u>Basement</u></b></p> <p>Several lights did not operate when tested. The bulbs may be blown.</p> <p>One gfci outlet near the return vent would not reset when when tested. Repair. (See picture #26)</p> <p>The rear exterior double doors would not close properly when tested. Readjust the door hardware.</p> <p><b><u>Living Room</u></b></p> <p>The bottom latch was broken on the front exterior double doors. Repair. (See picture #27)</p>

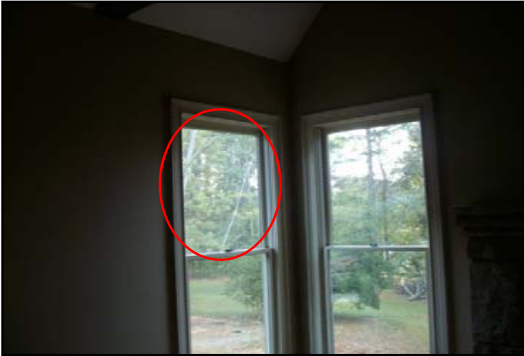
Location	Description	
<p>XVIII. Pictures #25 - #26</p> <div data-bbox="134 386 380 488" style="border: 1px solid black; padding: 5px; margin-top: 20px;">Broken window</div>

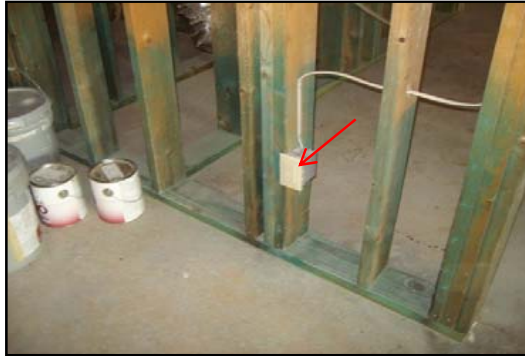
<div data-bbox="1709 396 1955 488" style="border: 1px solid black; padding: 5px; margin-top: 20px;">Outlet would not reset</div>
<p>#27 - #28</p> <div data-bbox="134 769 380 870" style="border: 1px solid black; padding: 5px; margin-top: 20px;">Broken latch</div>

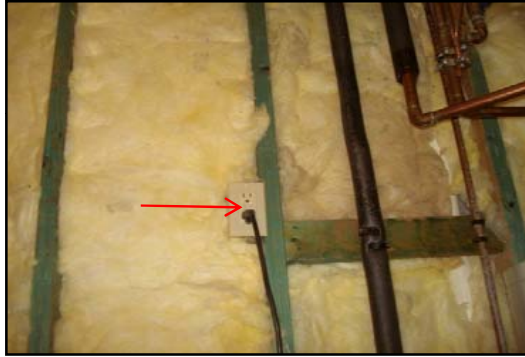
<div data-bbox="1709 743 1955 906" style="border: 1px solid black; padding: 5px; margin-top: 20px;">Condensate pump and recirculating pump plugged into gfcı outlets</div>
<p>#29 - #30</p> <div data-bbox="134 1149 380 1252" style="border: 1px solid black; padding: 5px; margin-top: 20px;">Humidifier unplugged and missing hose</div>

Location	Description
<b>VIII. Electrical</b>	The basement furnace condensate pump and water heater recirculating pump are currently plugged into gfci rated outlets. Recommend replacing outlets with a standard outlet to help prevent from accidental tripping of gfci outlets. (See picture #28)
<b>IX. Laundry Facilities</b>	The washing machine drain was capped. Recommend removing cap.
<b>XI. Heating</b>	The humidifier was unplugged and no drain hose was connected during the inspection. Repair. (See picture #29)  The air filter access covers are currently sealed shut on both furnaces. Repair.
<b>XIV. Attic</b>	Sunlight was noted around the furnace pvc draft pipe. Recommend further evaluation from a licensed roofer to ensure vents are sealed properly. (See picture #30)  No insulation depth markers were noted in the attic. Recommend installation at every 300 sq. ft. of attic space. Reference: 2006 IRC N1101.4.1  No insulation certificate was noted in the attic. Recommend installation. Reference: 2006 IRC N1101.4.2

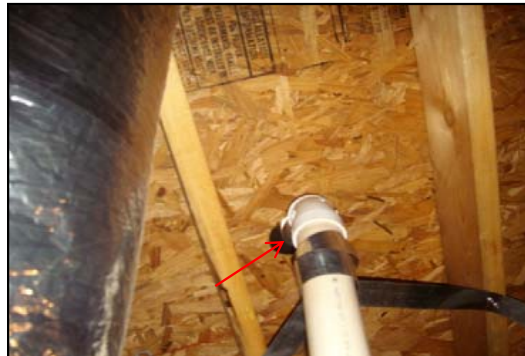
<div data-bbox="1709 1149 1955 1247" style="border: 1px solid black; padding: 5px; margin-top: 20px;">Daylight noted around vent pipe</div>
