CHAMP HOME INSPECTIONS

HOME INSPECTION REPORT

Date: 1/1/00

123 Any Street
Any Town, GA 30000

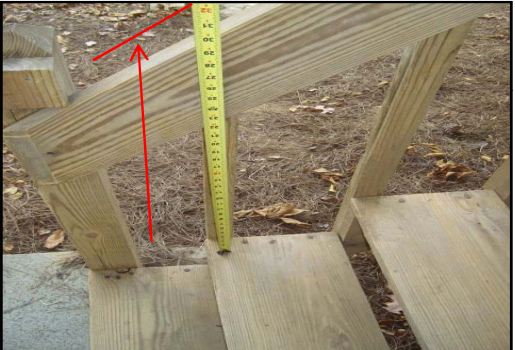
<div data-bbox="1671 792 1913 893" style="border: 1px solid black; padding: 5px; margin: 10px 0;"> <p>Hand railing too low</p> </div>

<input type="checkbox"/>	Gravel							
<input type="checkbox"/>	Other							
WALKS/STEPS								The guard railing picket spacing was too far apart. Recommend installing pickets no more than 4" apart for added safety. Rear Lower Deck The left deck post was attached to the side of the deck. Recommend installing additional board to deck post for direct support of the deck.
<input checked="" type="checkbox"/>	Concrete	<input type="checkbox"/>	Poor Earth to Wood Clearance					
<input type="checkbox"/>	Flagstone	<input checked="" type="checkbox"/>	Open Risers					
<input checked="" type="checkbox"/>	Brick	<input type="checkbox"/>	Settlement					
<input checked="" type="checkbox"/>	Wood	<input type="checkbox"/>	Handrail Loose/Missing					
<input type="checkbox"/>	Other	<input type="checkbox"/>	Trip Hazard					
PORCHES/SOOPS								The deck guard railing was too low. Recommend a minimum height of 36". The stair hand railing was too low. Recommend a hand railing height between 34" - 38" tall. The riser openings were too large for the rear deck stairs.

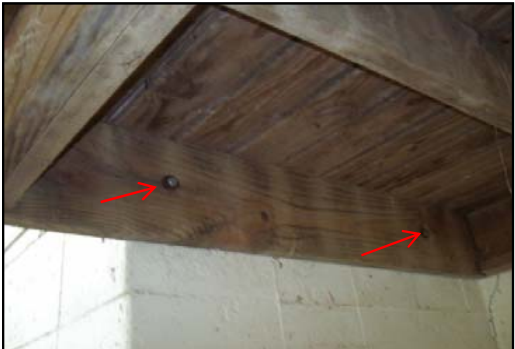
<div data-bbox="1671 1166 1913 1266" style="border: 1px solid black; padding: 5px; margin: 10px 0;"> <p>Rusted washers and bolts</p> </div>

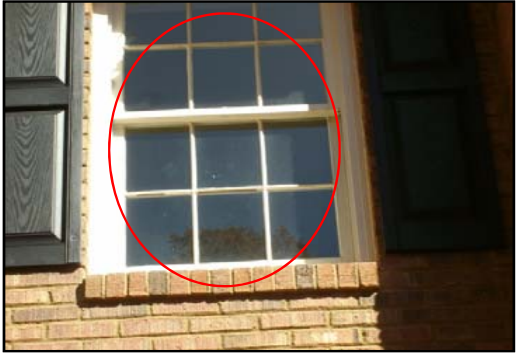
Location	Description	
<p>XVIII. Pictures</p> <p>#13 - #14</p> <div data-bbox="132 412 373 513" style="border: 1px solid black; padding: 5px; margin-top: 10px;">Loose glazing</div>

Location	Description
III. Exterior Surfaces (Con't.)	<p>Loose glazing was noted on several windows. Repair. (See picture #13)</p> <p>No screens were noted on the windows. Recommend installation.</p> <p>A negative pitch was noted on the trim above the front door. Repair. (See picture #12)</p> <p>The top piece of weather stripping was loose on the front door. Resecure.</p> <p>Torn weather stripping was noted on the rear exterior basement door. Repair.</p> <p>No flashing was noted above the rear exterior sunroom door and the right sunroom window. Recommend installation. (See picture #14)</p> <p>The front and rear exterior lights did not operate when tested. The bulbs may be blown.</p> <p>The front left light cover was broken. Repair. (See picture #12)</p> <p>Wood destroying organism damage was noted on the front right side of the house next to the dining room area. Repair. (See picture #15)</p>

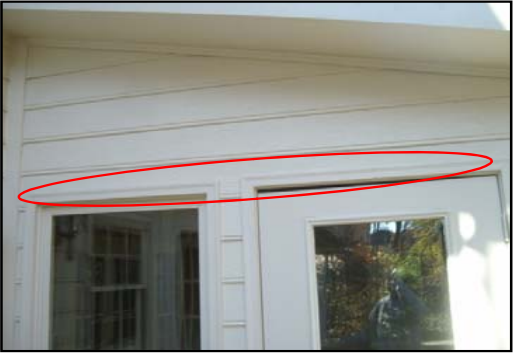
<div data-bbox="1671 412 1913 513" style="border: 1px solid black; padding: 5px; margin-top: 10px;">Top flashing missing above door and window</div>
<p>#15 - #16</p> <div data-bbox="132 792 373 893" style="border: 1px solid black; padding: 5px; margin-top: 10px;">Wood destroying organism damage</div>

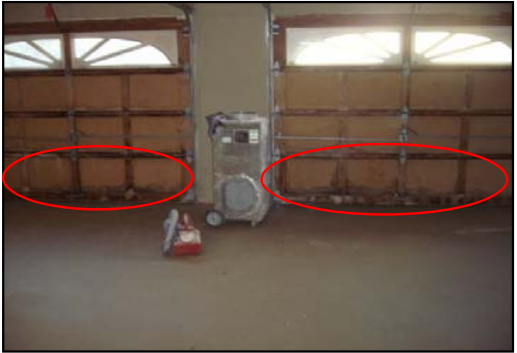
<div data-bbox="1671 792 1913 893" style="border: 1px solid black; padding: 5px; margin-top: 10px;">Water spots and rot on garage doors</div>
<p>#17 - #18</p> <div data-bbox="132 1166 373 1266" style="border: 1px solid black; padding: 5px; margin-top: 10px;">Vertical and diagonal cracks</div>

IV. Garage/Carport	<p>No power was indicated on the garage outlets. Recommend further evaluation from a licensed electrician.</p> <p>Water spots and rot was noted on the bottom panels of both garage doors. Repair. (See picture #16)</p> <p>Both garage door openers did not operate correctly when tested. Repair.</p>

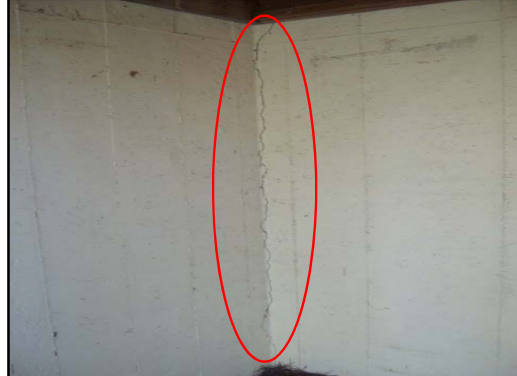
<div data-bbox="1671 1166 1913 1266" style="border: 1px solid black; padding: 5px; margin-top: 10px;">Vertical crack</div>

V. Foundation	<p>Vertical and diagonal cracks were noted on the rear foundation wall behind the garage and below the lower deck. Monitor for further cracking and seal as needed. (See pictures #17 - #18)</p> <p>Wood destroying organism tunnel was noted on the right foundation wall above the front right basement room. Recommend further evaluation from a licensed pest control company. (See picture #19)</p> <p>Possible microbial growths were noted on the walls in the basement utility room next to the water heater. Recommend further evaluation from a licensed mold expert. (See picture #20)</p> <p>Non-pressure treated wood was noted installed on the floor in the basement utility room and under the stairs. Recommend replacing with pressure treated wood, due to ground contact. (See pictures #21 - #22)</p>
VI. Kitchen	<p>The countertop outlets in the kitchen were not gfci rated outlets. Recommend replacing with gfci rated outlets for added safety.</p>

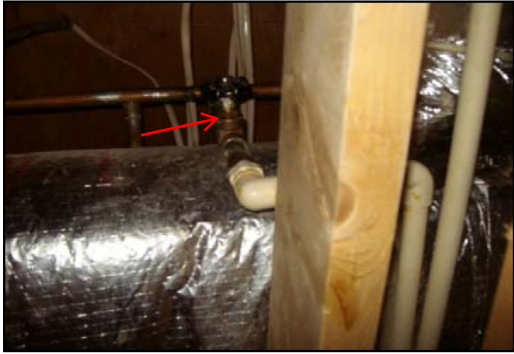
Location	Description	
<p>XVIII. Pictures</p> <p>#25 - #26</p> <div data-bbox="132 412 371 514" style="border: 1px solid black; padding: 5px; margin-top: 10px;"> Valve leaking </div>

<p>X. Plumbing</p>	<p>Water was noted dripping from a valve above the basement furnace. Repair. (See picture #25)</p>

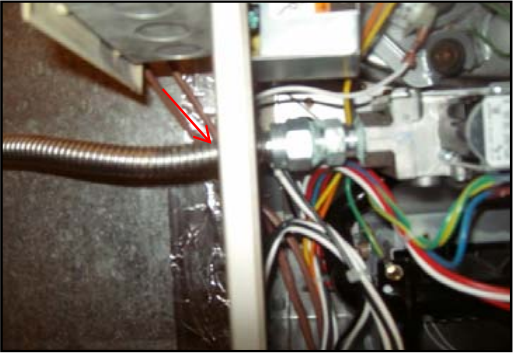
<div data-bbox="1671 412 1911 514" style="border: 1px solid black; padding: 5px; margin-top: 10px;"> Flexible gas line entering furnace </div>
<p>#27 - #28</p> <div data-bbox="132 776 371 911" style="border: 1px solid black; padding: 5px; margin-top: 10px;"> Gas line not supported and flexible gas line entering furnace </div>

Location	Description
XI. Heating	<p>Recommend installing a protective cover around the flexible gas line at the point of entry into both furnaces. (See picture #26 - #27)</p> <p>The gas line for the attic furnace was not supported properly. Repair. (See picture #27)</p> <p>The air filter access covers were missing on both furnaces. Install.</p>
XII. Air Conditioning	<p>The left ac unit was running while the thermostats were in heat mode and the ac line was frozen. Recommend further evaluation from a licensed HVAC contractor. (See picture #28)</p> <p>Torn insulation was noted on the ac line at the point of entry into the attic furnace. Repair.</p>
XIII. Water Heater	<p>The thermal expansion tank was not supported properly. Repair. (See picture #29)</p> <p>The tpr valve pipe terminates into the furnace condensate pump. Recommend terminating pipe either to the floor of the basement or to the exterior of the house. (See picture #30)</p>

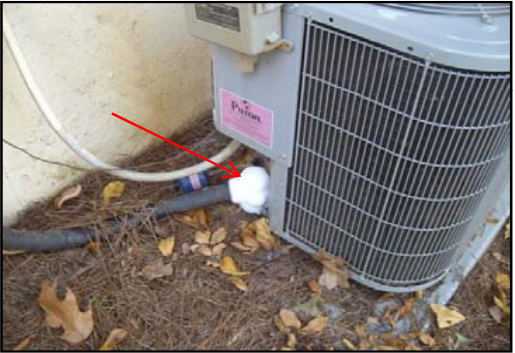
<div data-bbox="1671 792 1911 894" style="border: 1px solid black; padding: 5px; margin-top: 10px;"> Ac line frozen </div>
<p>#29 - #30</p> <div data-bbox="132 1166 371 1268" style="border: 1px solid black; padding: 5px; margin-top: 10px;"> Thermal expansion tank not supported </div>

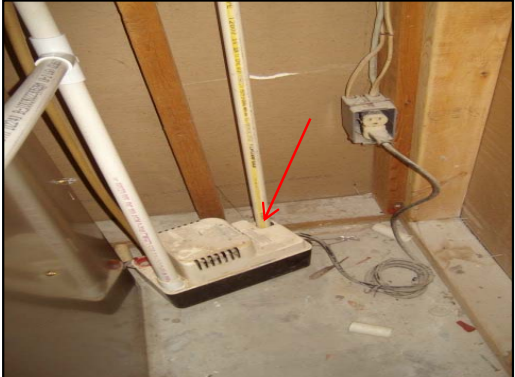
<div data-bbox="1671 1166 1911 1268" style="border: 1px solid black; padding: 5px; margin-top: 10px;"> Tpr valve pipe terminates into condensate pump </div>
