CHAMP HOME INSPECTIONS

HOME INSPECTION REPORT

Date: 1/1/00

123 Any Street
Any Town, GA 30000

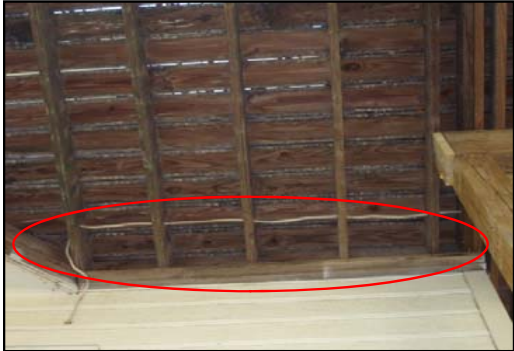
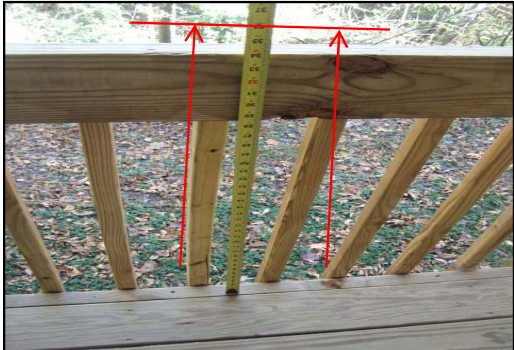
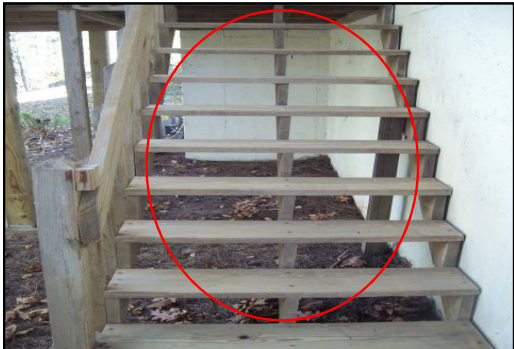
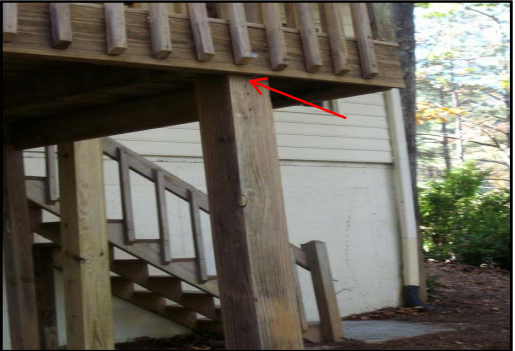
Location	Description	
<p>XVIII. Pictures</p> <p>#1 - #2</p> <div data-bbox="132 412 373 513" style="border: 1px solid black; padding: 5px; margin: 10px 0;"> <p>No flashing and exposed wire</p> </div> <p>#3 - #4</p> <div data-bbox="132 792 373 893" style="border: 1px solid black; padding: 5px; margin: 10px 0;"> <p>Guard railing too low</p> </div> <p>#5 - #6</p> <div data-bbox="132 1166 373 1266" style="border: 1px solid black; padding: 5px; margin: 10px 0;"> <p>Riser openings too large</p> </div>

<div data-bbox="1671 412 1913 513" style="border: 1px solid black; padding: 5px; margin: 10px 0;"> <p>Post attached to side of deck</p> </div>

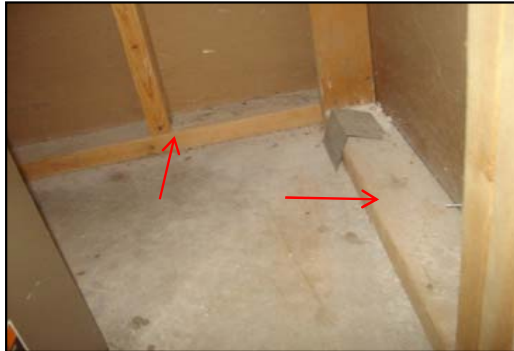
Location	Description	
<p>XVIII. Pictures</p> <p>#19 - #20</p> <div data-bbox="132 412 371 514" style="border: 1px solid black; padding: 5px; margin-top: 10px;"> Wood destroying organism tunnel </div>	 	  <div data-bbox="1671 412 1911 514" style="border: 1px solid black; padding: 5px; margin-top: 10px;"> Possible microbial growths </div>
<p>#21 - #22</p> <div data-bbox="132 792 371 894" style="border: 1px solid black; padding: 5px; margin-top: 10px;"> Non-pressure treated wood touching ground </div>

<div data-bbox="1671 792 1911 894" style="border: 1px solid black; padding: 5px; margin-top: 10px;"> Non-pressure treated wood touching ground </div>
<p>#23 - #24</p> <div data-bbox="132 1166 371 1268" style="border: 1px solid black; padding: 5px; margin-top: 10px;"> Cracks noted in fireplace </div>	 	  <div data-bbox="1671 1166 1911 1268" style="border: 1px solid black; padding: 5px; margin-top: 10px;"> Panel boxes located in bathroom </div>
